## **Tool 3 : Lessons Learned from the Extreme Natural Disasters**

## 6 Results of Field Survey on Typhoon No. 5: JEBI (2013)

## The Impact of January & February 2014 Jakarta Flood to the Industrial Park in Jakarta and Bekasi

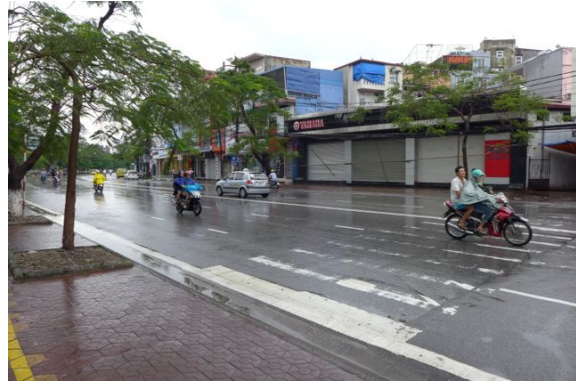
**Photo 6.2** Street in front of Nam Cuong Hotel in the City of Hai Phong before arrival of typhoon. Much fewer traffic as compared to the usual condition.

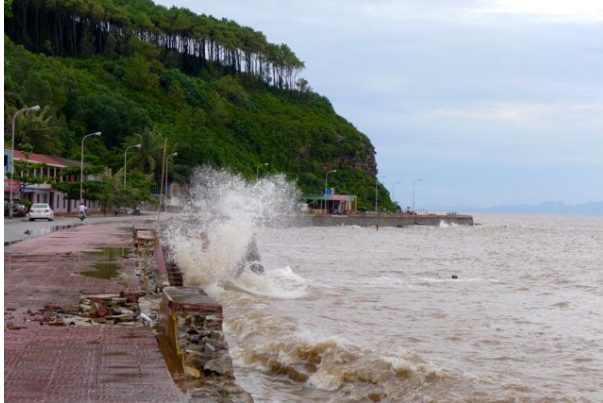
**Photo 6.4 Coastal dyke damaged at Do Son Area (Unknown if the damage caused by Typhoon No. 5 JEBI:JEBI(2013))**

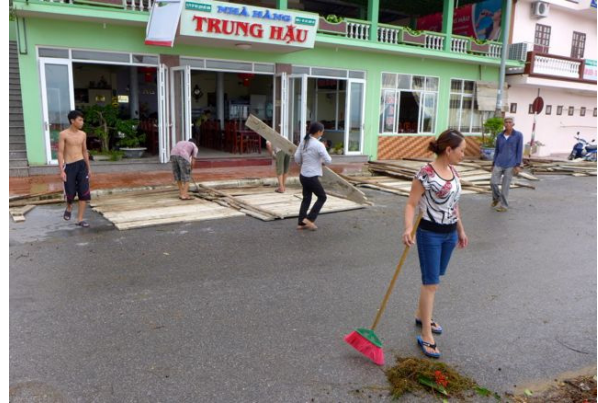
The observed damages at Do Son area include coastal dyke damages at few locations (unknown if they were caused by Typhoon No. 5). In the afternoon of August 3<sup>rd</sup>, people were out cleaning the aftermath of the typhoon and removing plywood which was used to protect the commercial facilities (restaurants and hotels) located along a road facing the South China Sea. At a dock, as a typhoon measures, boats were tied to trees along embankment.

**Photo 6.5 People cleaning the aftermath of typhoon and removing plywood used to protect doors and windows.**

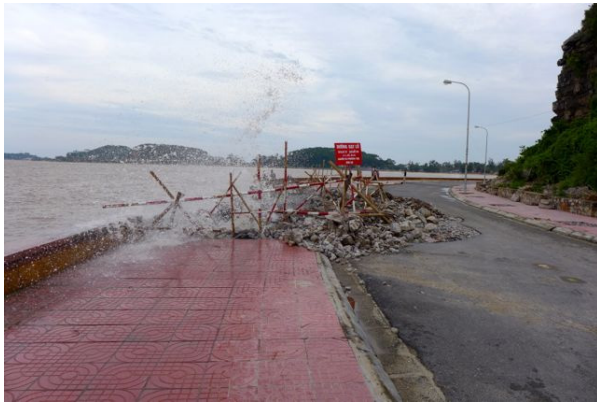
**Photo 6.6 Coastal dyke damaged at Do Son Area (Unknown if the damage caused by Typhoon No. 5 JEBI:JEBI(2013))**

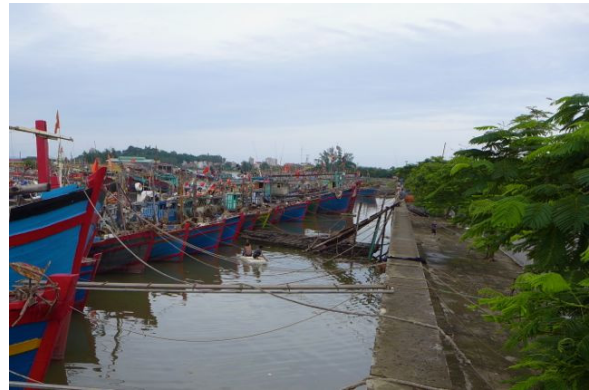
**Photo 6.7 Prevention measures to protect boats by strapping to trees along embankment at Do Son area**

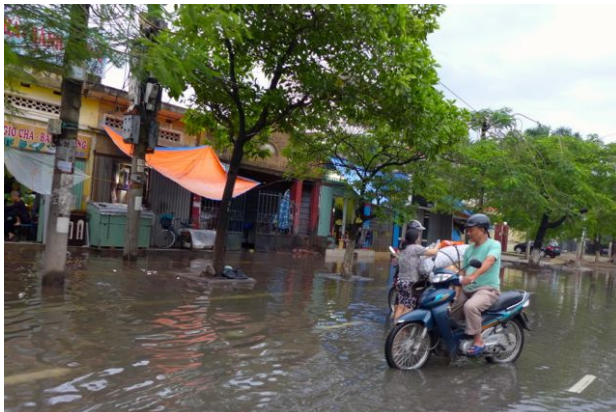
Within the city of Hai Phong, inundations caused by inland water were recorded, especially along major roads and lowlands (university campus). However, the investigation from the Bin Bridge across the Cam River indicated that there was no damage along the river.

**Photo 6.8 Inundation in the City of Hai Phong**

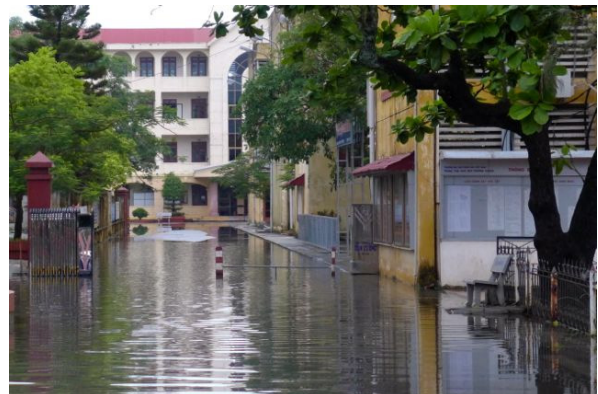
**Photo 6.9 University Campus Inundated in the City of Hai Phong**

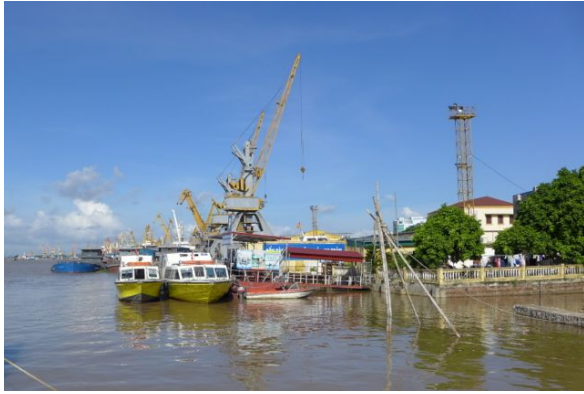
**Photo 6.10** Looking downstream from a commercial port (tour boats for Catba island) located on right bank of Cam River

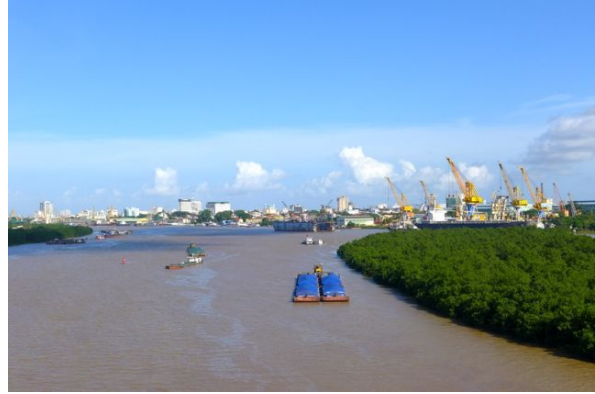
**Photo 6.11** Looking downstream of the Cam River from the Bin Bridge

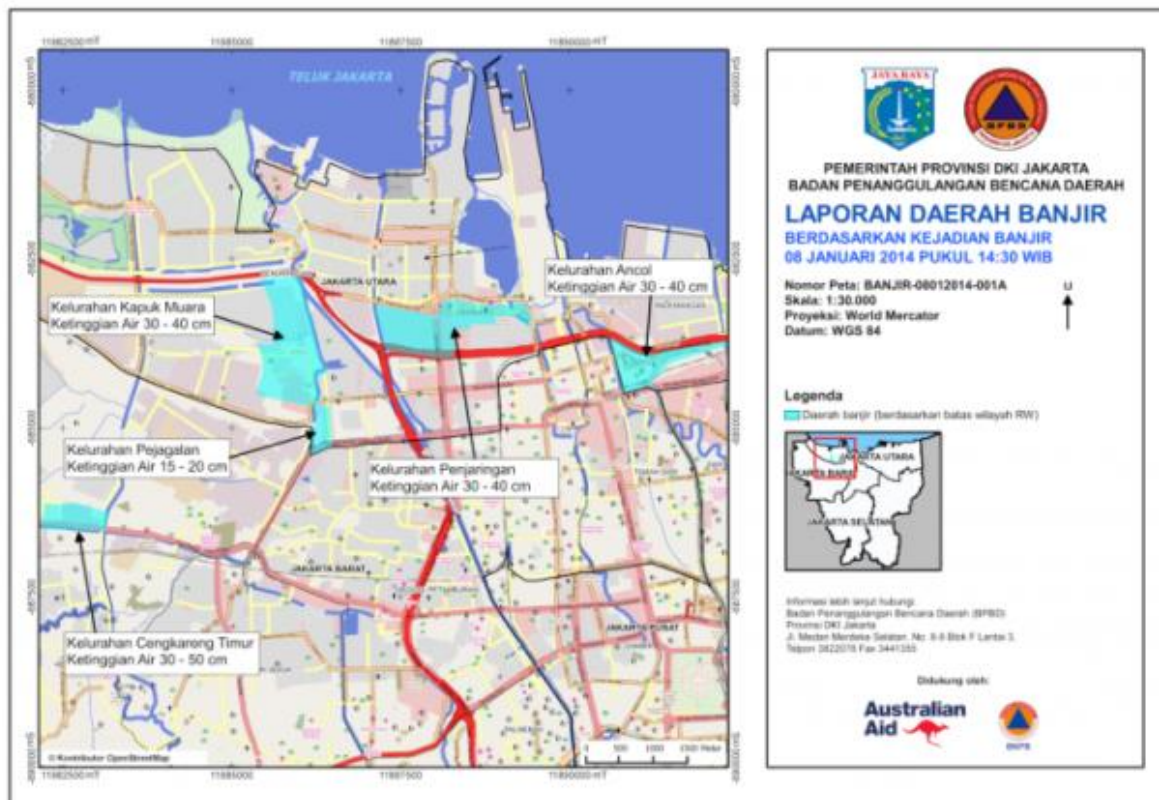
Regarding the 2104 Jakarta Flood, Local Disaster Management Agency (BPBD) of DKI Jakarta Province mentioned that the inundation was started on January 8, 2014. Initially flood inundated North and East Jakarta. Figure 1 shows the flood inundation maps on January 8, 2008, which was published by BPBD of DKI Jakarta Province.

Figure 1a. Flood Inundation Area in North Jakarta on January 8, 2014

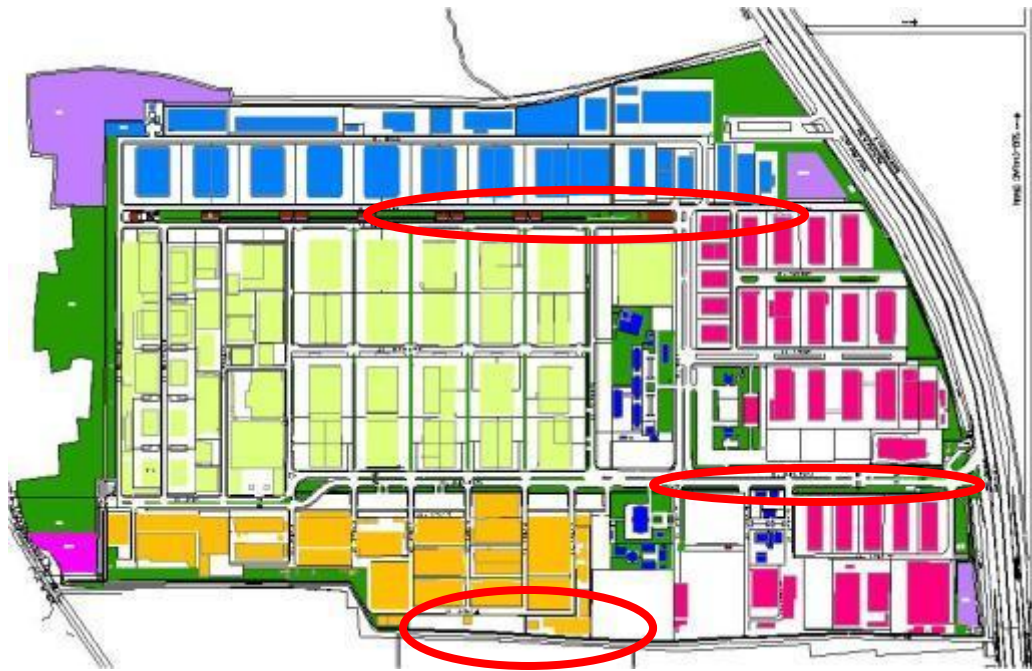
Different with industrial parks in Bekasi area, the visited industrial park in Jakarta (KBN Cakung) was inundated by 2014 Jakarta flood especially in the main gate area. The height of flood is about 50-60 cm, and in some areas the height of flood is about 50-80 cm (Figure 4). Figure 5 shows the inundation in KBN Cakung industrial park.

Figure 4. Map of KBN Cakung Industrial Park. The areas in red circle were inundated by 2014 Jakarta Flood (Source: KBN Cakung)

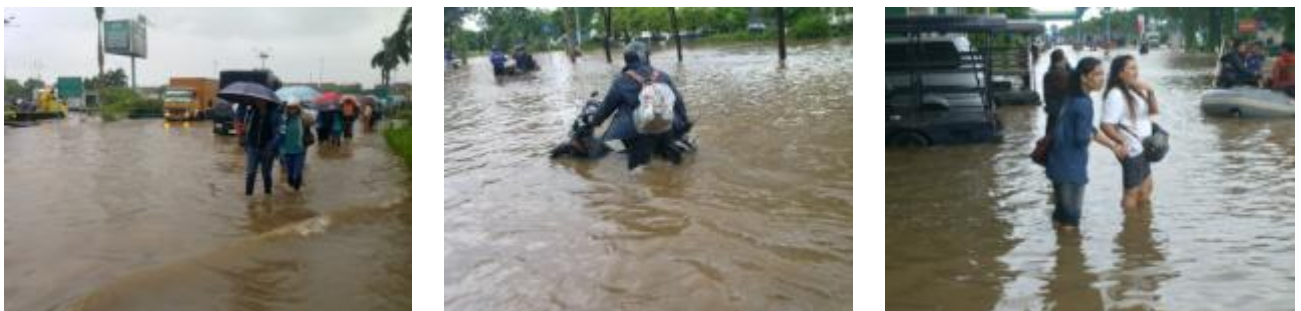
Figure 5. Flood Inundation in KBN Cakung Industrial Park (Source: KBN Cakung)

The flood did not inundate the industry buildings, but since the main gate and some of streets in KBN Cakung were inundated and some workers' houses were also inundated by flood, therefore, on Friday, 7 February 2014 some industries allowed the workers to go home. They also made one day off for the workers on Monday, 10 February 2014.

From the past flood experiences (in 2007 and 2002), KBN Cakung also provides 10 water pumps and develops two ponds as catchment area to reduce the inundation areas if flood occurs. Besides, many industries have raised their building up and put vital assets to higher place (second floor). KBN Cakung also has Flood Response Team to cope with the problems due to a flood disaster.

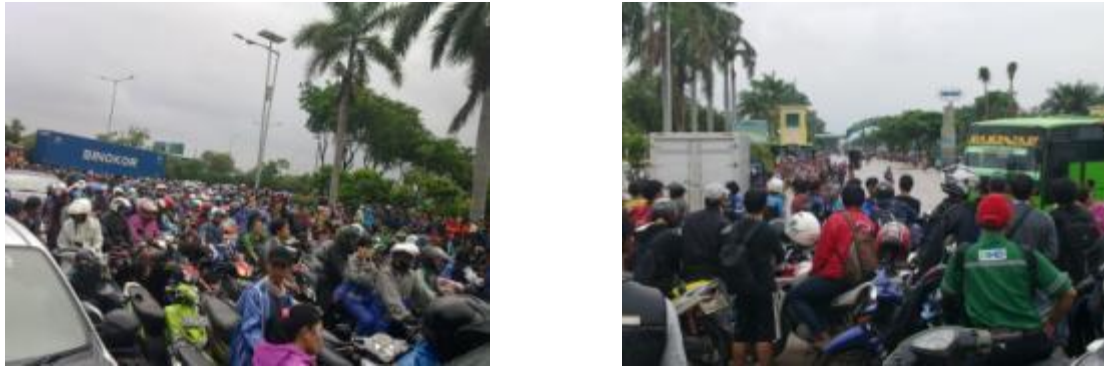
Flood inundation also disturbed the logistic of material and product distribution from KBN Cakung industrial park, due to the traffic jam cause by the inundation. (Figure 6).

Figure 6. Traffic Jam on Main Gate of KBN Cakung (Source: KBN Cakung)

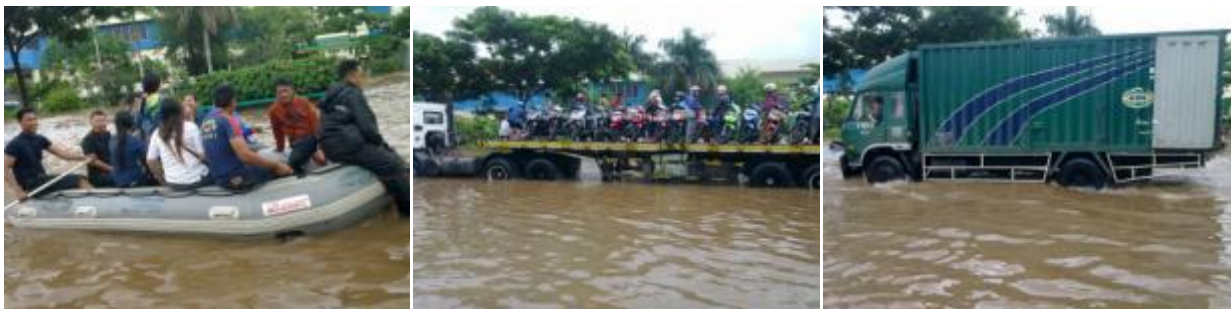
Internally, KBN Cakung has also some strategies to respond to the problem of inundation on the main gate and on some streets within the industrial park for the industrial workers, such as providing rubber boat or other transportation means to bring the workers to the industry buildings (Figure 7).

Figure 7. PT.KBN Cakung provides transportation means inside the industrial areas to bring the workers to the industry buildings (Source: KBN Cakung)

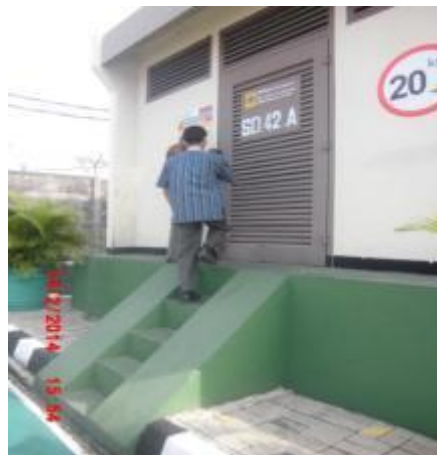
In industrial areas, PT. PLN has built electrical substation in two methods. First, the substation is put in the basement, and second, the substation is put on the ground surface. The substation in the basement is more vulnerable towards flood disaster, so PT. PLN has moved some of the substation to the safer place.

The substation that is located on the ground surface is still lower than flood level. It is also lower than the industrial floor level, which have been raised above the flood level. PT. PLN has raised one substation building to mitigate the flood impact (Figure 9), but some of them are still not raised yet. The substations which are not raised yet are very vulnerable towards flood disaster. If the substation is inundated, the electric power can be shut down.

Figure 9. Substation building that has been raised (ASTRA Daihatsu Jl. Danau Sunter Utara)
